# Manhole Inspection Summary

Manhole # S31K1\_002MH

**Location** Address: **2465 Seamon Avenue**

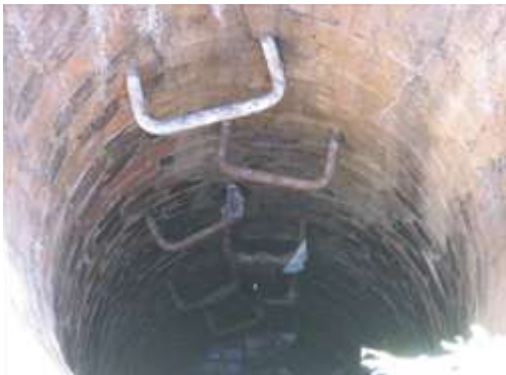
Count: **8** Missing: **0** ☒ **Corroded**

Steps

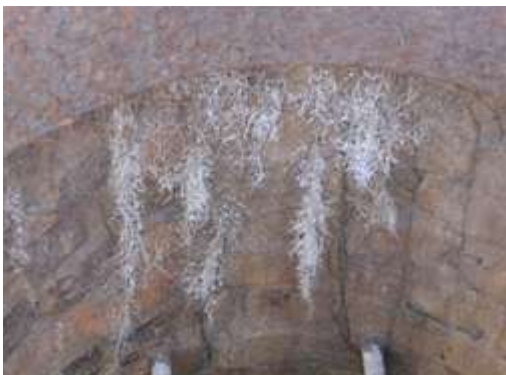
Defect 1

Infiltration: ☐ None ☐ Joint ☐ Cracks ☐ Mortar ☒ **Roots** ☐ Wall

Roots

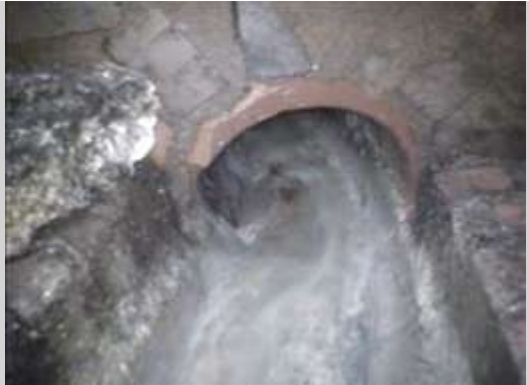
12 O'Clock Outflow

8 in. Circular Gravity Sewer  
Pipe Out @ 12 O'Clock

Pipe Height: **8.4** (in.) Rod and Bar (Angled)  
Pipe Material: **Clay** ☐ Pipe Lined  
Invert Depth: **13.87** (ft.) Flow Characteristics: **Fast**  
Deposits: ☒ None ☐ Mud ☐ Sludge ☐ Debris ☐ Grease  
Silt Depth: (in.) Deposits Extent:  
Infiltration: **None** Pipe Seal Cond: **Sound**

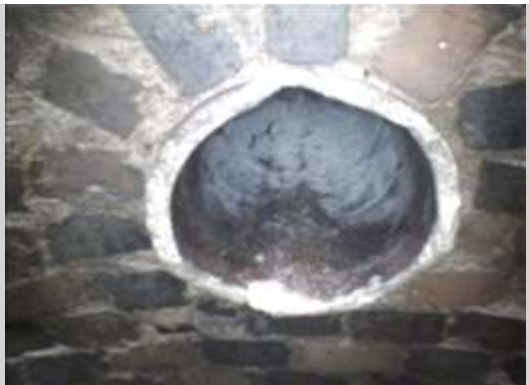
6 O'Clock Inflow

8 in. Circular Gravity Sewer  
Pipe In @ 6 O'Clock

Pipe Height: **8.4** (in.) Rod and Bar (Angled)  
Pipe Material: **DIP/CI** ☐ Pipe Lined  
Invert Depth: **10.97** (ft.) Flow Characteristics: **Fast**  
Deposits: ☒ None ☐ Mud ☐ Sludge ☐ Debris ☐ Grease  
Silt Depth: (in.) Deposits Extent:  
Infiltration: **None** Pipe Seal Cond: **Sound**

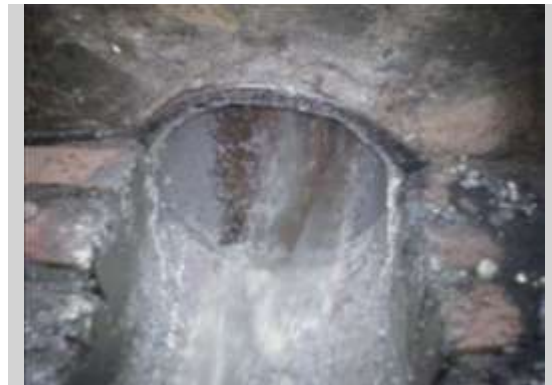
Drop In @ 6 O'Clock

Drop: **Outside** Rod and Bar  
Angled: **Yes** Reading: **12.73** (ft.)  
Inv Depth: **13.73** (ft.)  
Drop Condition: **Open**

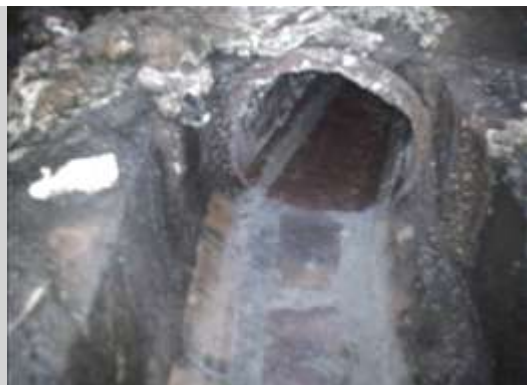
7 O'Clock Inflow

6 in. Circular Gravity Sewer  
Pipe In @ 7 O'Clock

Pipe Height: **7.2** (in.) Rod and Bar (Angled)

Pipe Material: **Clay** ☐ Pipe Lined

Pipe Seal Cond: **Sound**
